PROJECT Madison High School Stadium Renovations
FIELD REPORT

PROJECT Madison High School Stadium Renovations
PROJECT NO 0201-199620
CONTRACT
FIELD REPORT NO
DATE 01-11-2023
TIME 3:00pm
WEATHER Mostly Sunny, Clear
TEMP RANGE Mid 50's
PRESENT AT SITE Dr. Will Hoffman, Philip Cannady, Michael Jackson, Chris Otahal, Ian Johnson, Scott Donald, Rob Stenhouse
DISTRIBUTION Dr. Will Hoffman, Philip Cannady, Michael Jackson, Chris Otahal, Ian Johnson, Scott Donald, Rob Stenhouse
REPORT BY Rob Stenhouse, Assoc. AIA

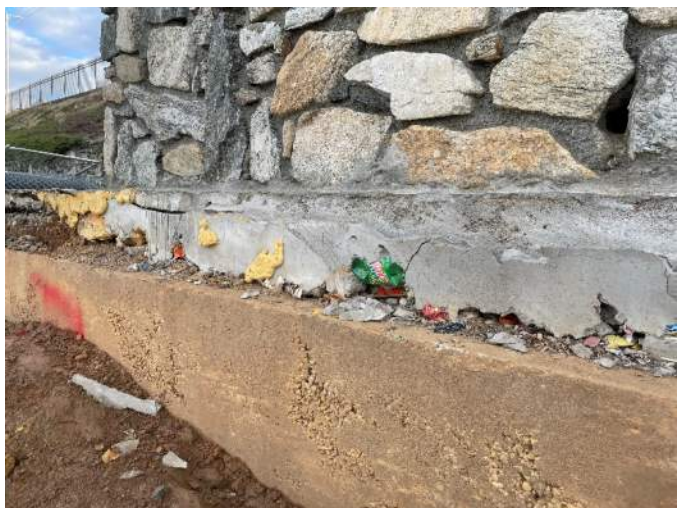
^ Sloppy crack infill between pre-cast and upper concourse

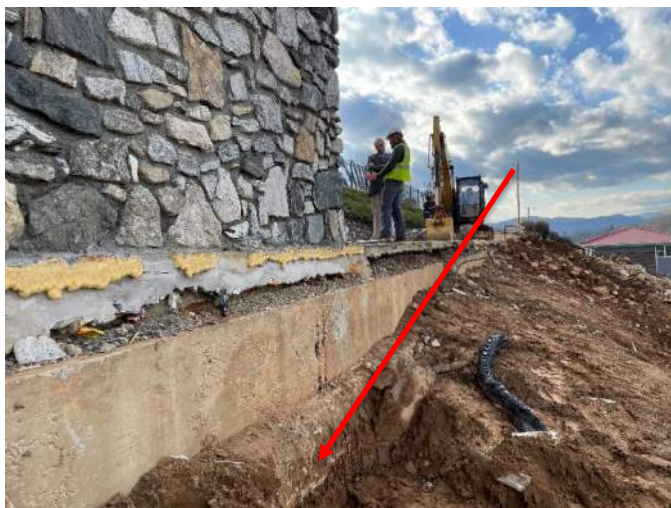
^ Sloppy Infill – exposed footing to be covered

I agree – the contractor should bury the base of the exposed footing approximately 18 inches and provide 2 feet of lateral cover prior to sloping at 2H:1V to tie into existing grades. If the existing geometry in the area prevents the 2H:1V, the contractor may place backfill at a steeper inclination for this temporary buttress. Contractor should use compacted soil, or could use ABC stone. 95% compaction (ASTM D698) is recommended.

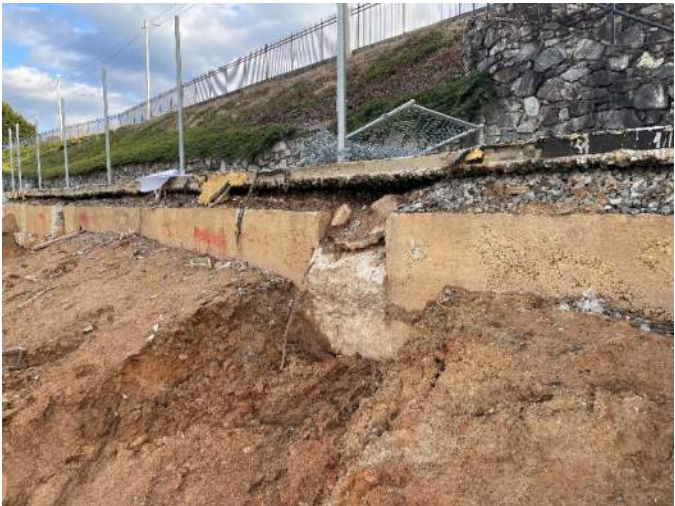
^ Raker beam remnants between retaining wall sections

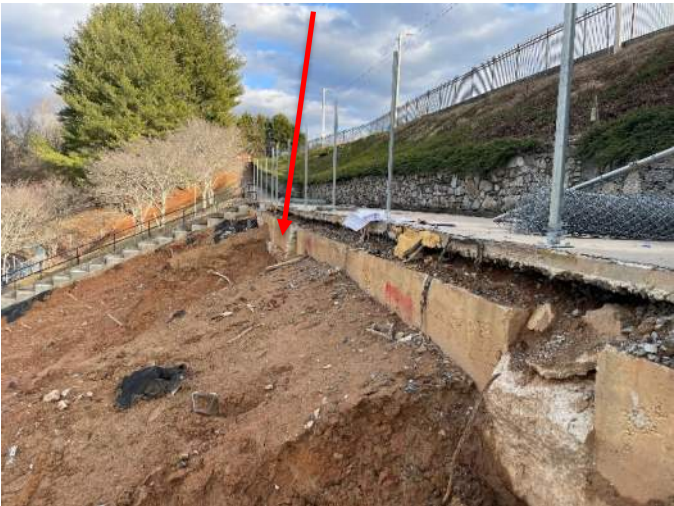
- Upper foundation and retaining wall exposed
 - To east of Pressbox, area of erosion undercutting the upper retaining wall and footing noted.
 - Nearby, near a raker beam and retaining wall gap, what looks to be grout fill was observed beneath the footing, possibly poured in place as a repair.

^ Arrow indicates significant foundation undercut erosion with a potential existing grout repair below footing

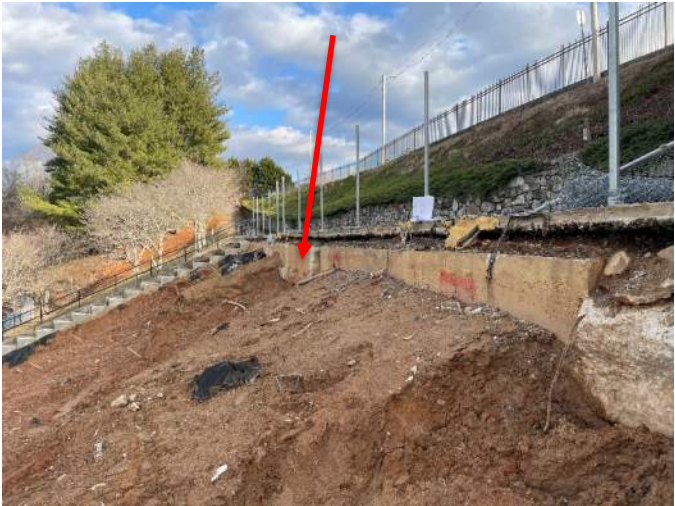
^ Demolition – arrow at undercut footing

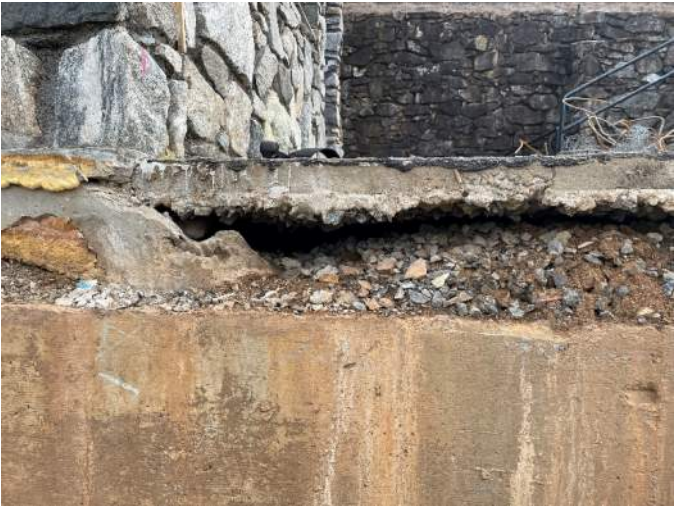
- At north side, appears some stone veneer may sit atop retaining wall, but not verified
- Through gaps in stone veneer, looked to verify where structural backup wall for pressbox was located.
- At NW corner outside of pressbox, a gap was observed where gravel support for upper concourse walk was missing or eroded away. Asked GC to remove sidewalk in this area, adjacent to building to see how far the missing gravel base extended. See additional notes below.
- Sloppy grout infill poured to fill gaps between concourse and back of pre-cast planks obscuring view to verify stone veneer and wall relationship.

- Sidewalk area removed at outside NW corner of pressbox as requested, 01/12/2023.
 - Missing gravel extends under pressbox building. A 4'-0" level extends at least 3'-0" past the exterior face of stone veneer under building. Further exploration needed to discover where structural wall is located.
 - H&M will fill this hole with gravel/dirt as best they can and stabilize before heavy rain expected Thursday evening.
 - Retaining wall foundation at pressbox will need to be covered. Email chain with instructions from Ian Johnson PE attached.

^ Gap below sidewalk – asked H&M to remove portion of walk to explore extents of hole

Additionally, as discussed yesterday, the two micropiles at the press box should be installed before construction at column C-4.

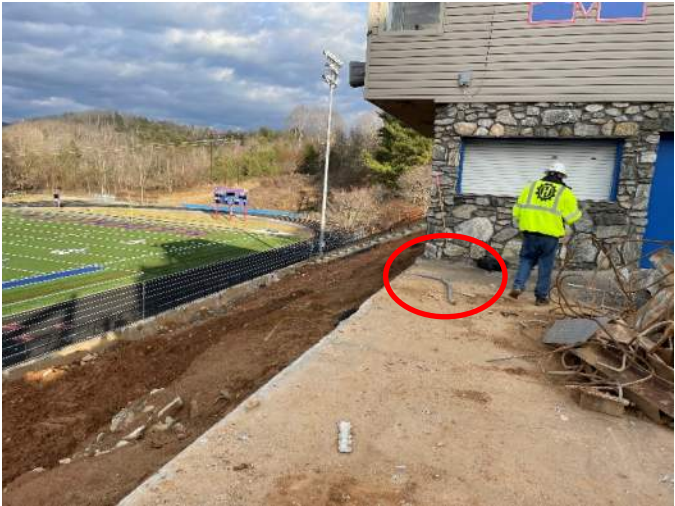
^ Portion of sidewalk at building corner to be removed

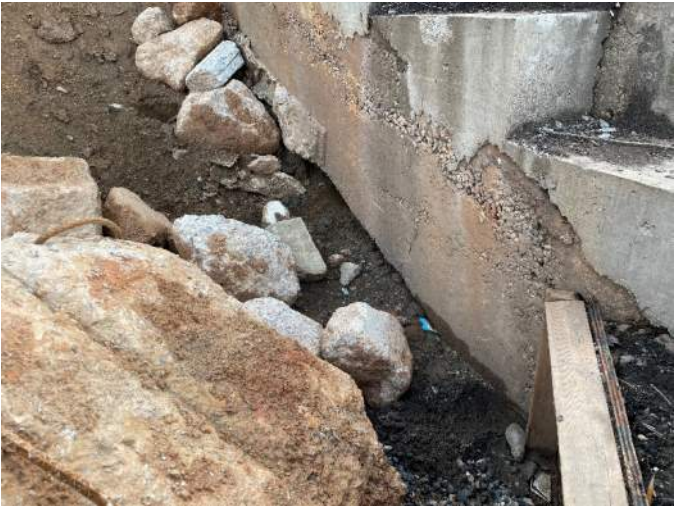
^ Eroded undermining at west raker beam / retaining wall

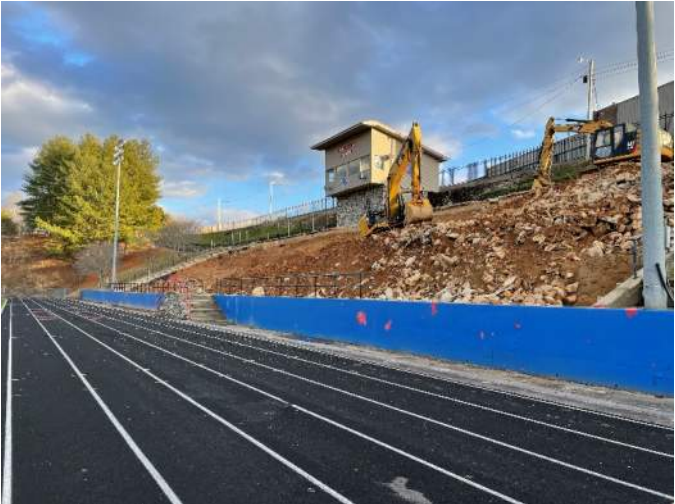
^ Overall homeside demolition view – existing rock steps to be demolished as well
